## CE 487 Senior Design Project

## SACS Environmental Study Center Bridge Replacement

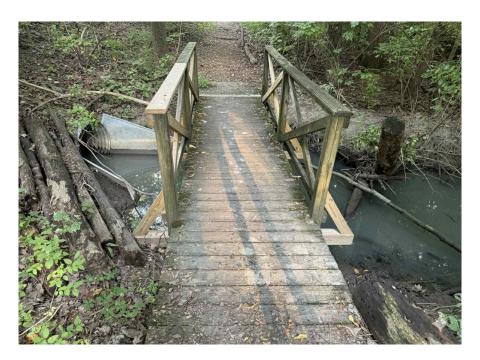
An existing bridge located on the trail system in the Southwest Allen County Schools Environmental Study Center needs to be demolished and replaced due to its poor condition from aging and weathering, as shown in Figure 1. Currently, this bridge is utilized by the public, who use the trail system to walk their dogs, exercise, and explore nature, to name a few uses. Additionally, the students and teachers at Southwest Allen County Schools utilize this area for lessons. This bridge goes over an unnamed ditch that drains to the Graham-McCulloch Ditch. The Graham-McCulloch Ditch is regulated by the Allen County Surveyor and by the Indiana Department of Natural Resources.

Figure 1. A photo of the current bridge.
